# Buildings & Grounds Committee

Attachment: dome-10092024110809 (12557 : Dome Restoration)

Vertical Access LLC (VA) was retained by Bell & Spina, P.C. to perform a hands-on and close visual inspection of the exterior of the sheet metal-clad dome and masonry drum of the Cortland County Courthouse in Cortland, NY. The purpose of the survey was to document existing conditions in order to assist the project team with preparation of repair recommendations. As part of the investigative work, VA documented representative and notable conditions with digital photographs and video files hyperlinked to annotated conditions drawings.

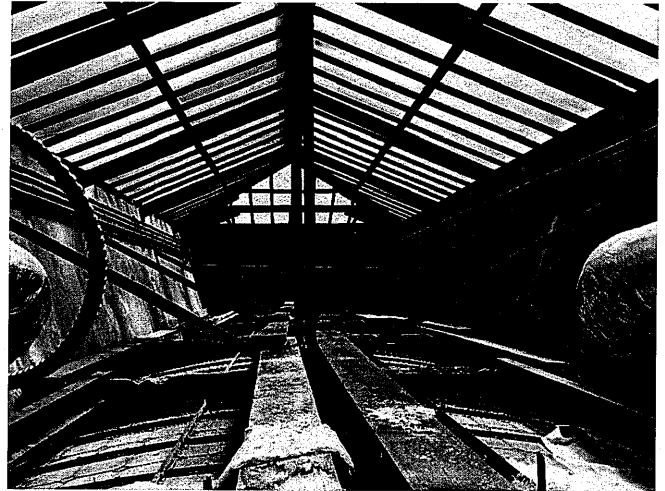
Each section of the building's cross has a skylight. The skylights vary in size and are directly over stained glass ceiling murals located in the rooms below. The skylight frames are the original copper holding a single pane wire glass.

The area between the skylight and the mural is heated.

1. Skylights are original, have exceeded their life expectancy, are energy inefficient, and leak.

Full replacement with insulated glazing and thermally broken framing system replicating the existing skylight pattern.

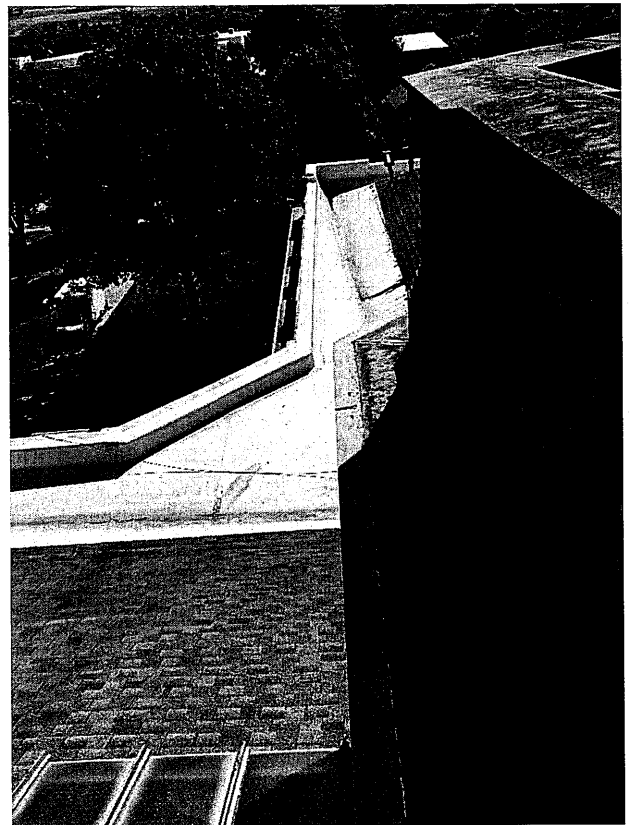
Cornice at Balustrade =Dome Level 2

The outer cornice is flashed and coated with an aluminum fibrated coating similar to that coating the membrane. The flashing is counter flashed at the balustrade and is set into a Reglet with sealant set back from the edge of the cornice. The sealant is deteriorated.

1. Repoint areas of deterioration, that have the incorrect mortar, and that have been caulked.
2. Install dutchman repairs at major spalls.
3. Clean the cornices, rotunda drum and balustrade masonry.
4. Remove the copper flashing at the cornices, repair masonry and install new flashing.

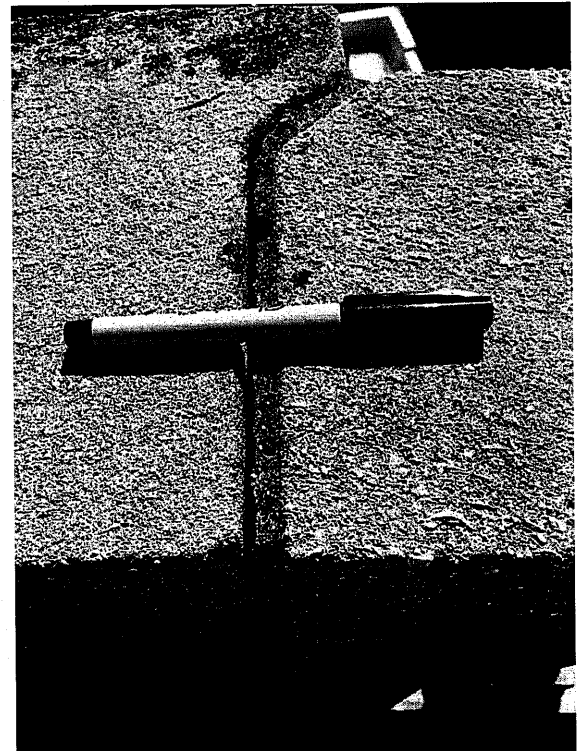
Balustrade Joints

The balustrade is 43 inches high. The joints of the balustrade are open, deteriorated and some sections have shifted.

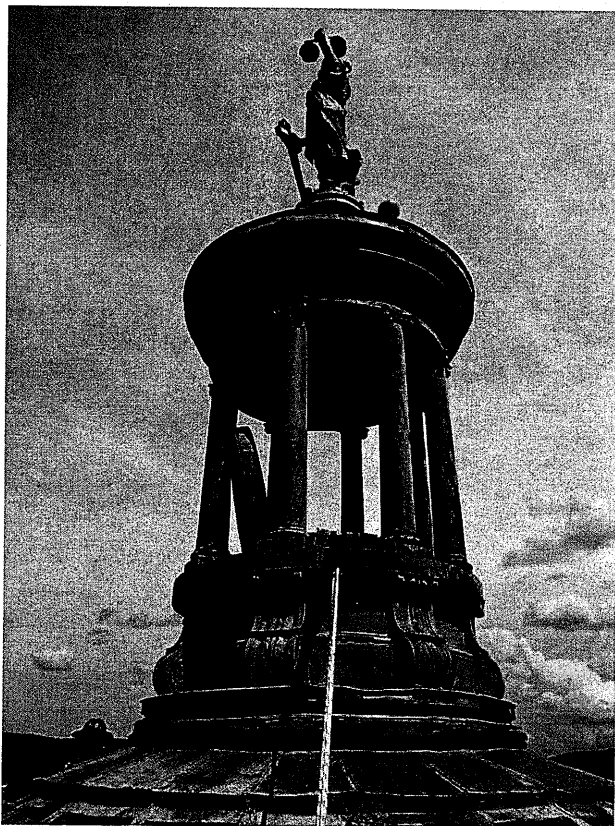
Lantern and Lady Justice

- 3.4.4 The fifth level is reached via a circular stair which then has a circular stair to a hatch at the top of the dome under the lantern which is topped by a statue of Lady Justice. The lantern, its eight ionic columns, and Lady of Justice are copper. The surface of the dome is 24 oz. copper in twenty-four (24) pie sections. The copper has been painted, which was reportedly done at the start of World War II. The paint color is a yellow that has worn away in areas and is very thin in others. The paint is assumed to contain lead.

Lady Justice and the columns of the lantern are in a similar condition as the dome copper, replicated replacement utilizing 20 oz copper.

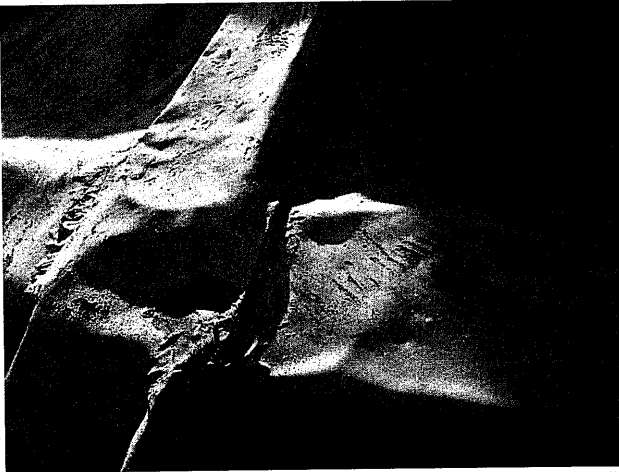
Dome Seams

- A typical pattern of deterioration at the sheet metal dome is failed soldered seams (annotated "SldF" on the drawings) at the ribs covers where they meet the sheet copper lantern skirt near the top of the dome. The failed seams are typically three or four inches long. (See photographs 107-137, 595-136, 853-134).

Coating the dome copper was considered but the lead paint coating would have to be removed first in order to conduct repairs and provide a good surface for coating adhesion. Therefore, replicated replacement with 20 oz copper is recommended.

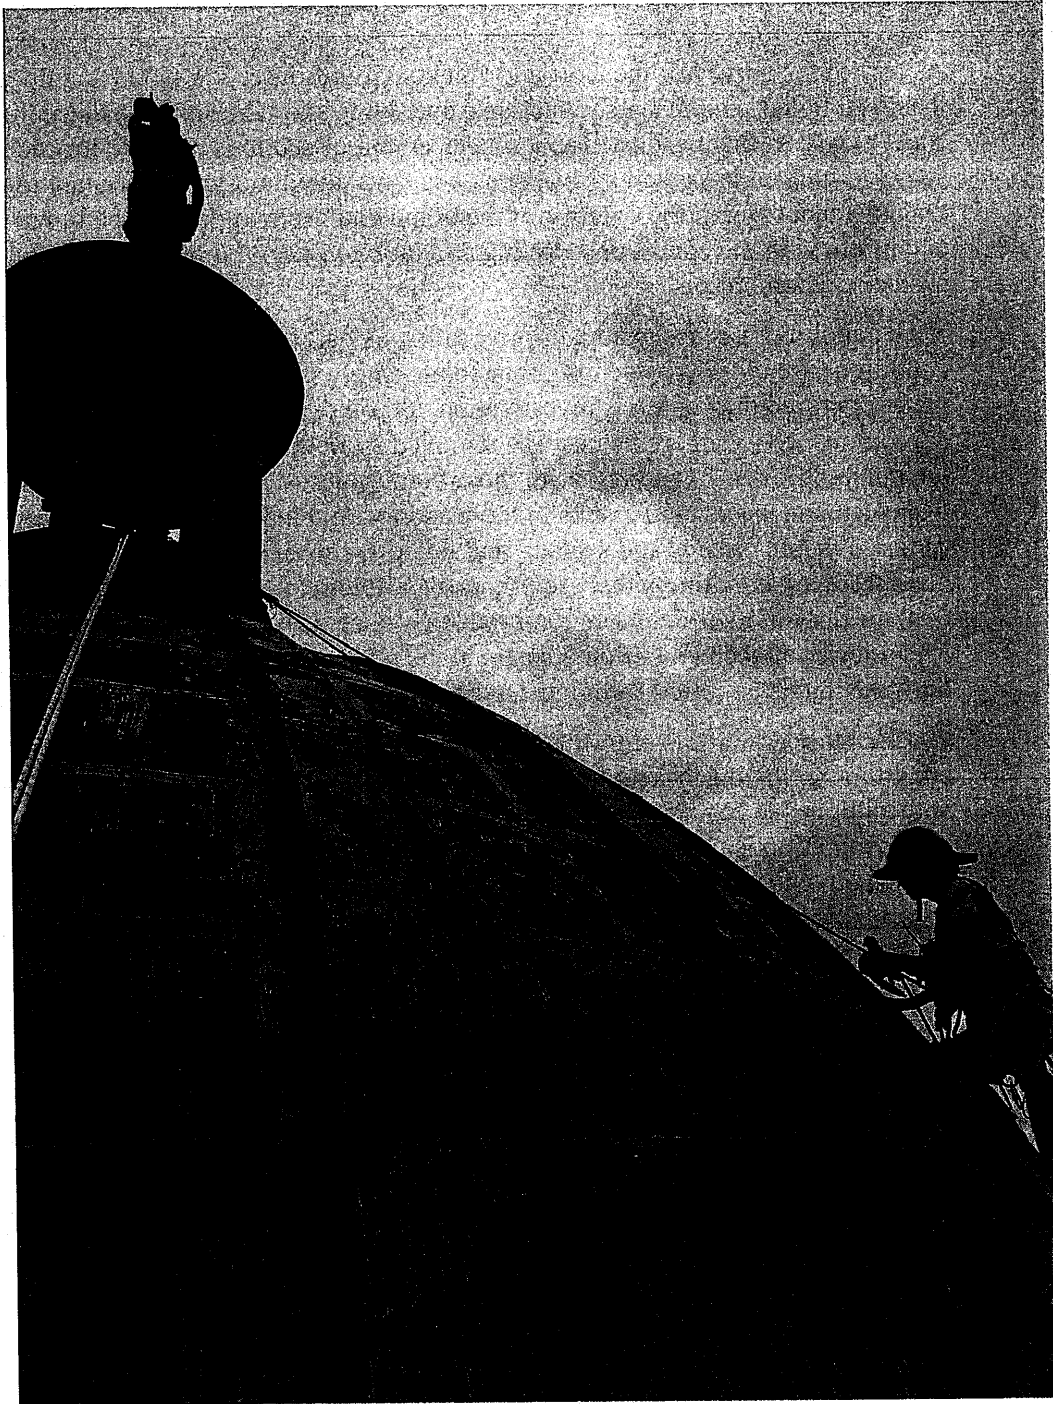
Figure 2: Dome photograph showing pans and rib covers.

- The sheet copper cladding at the exterior of the dome and lantern is in fair to good condition. There are 24 facets of the sheet metal dome, consisting of sheet copper pans with the folded seams at the top and bottom seams of the pans and the sides turned up and covered by sheet copper rib covers. Sheet copper ornament at the dome and lantern includes brackets at the base of the dome, volutes at the base of the lantern, and eight columns with ionic capitals at the lantern. Measurements taken at several locations with digital calipers indicate that the copper is nominally between 0.031 and 0.040 inches thick, corresponding roughly to 24 oz. sheet copper. (See photographs 119-123,
