# Public Works Committee

## Special Meeting

**AGENDA ITEM NO. 3 – Award Courthouse Dome Repair and Painting**

Vertical Access LLC (VA) was retained by Bell & Spina, P.C. to perform a hands-on and close visual inspection of the exterior of the sheet metal-clad dome and masonry drum of the Cortland County Courthouse in Cortland, NY. The purpose of the survey was to document existing conditions in order to assist the project team with preparation of repair recommendations. As part of the investigative work, VA documented representative and notable conditions with digital photographs and video files hyperlinked to annotated conditions drawings.

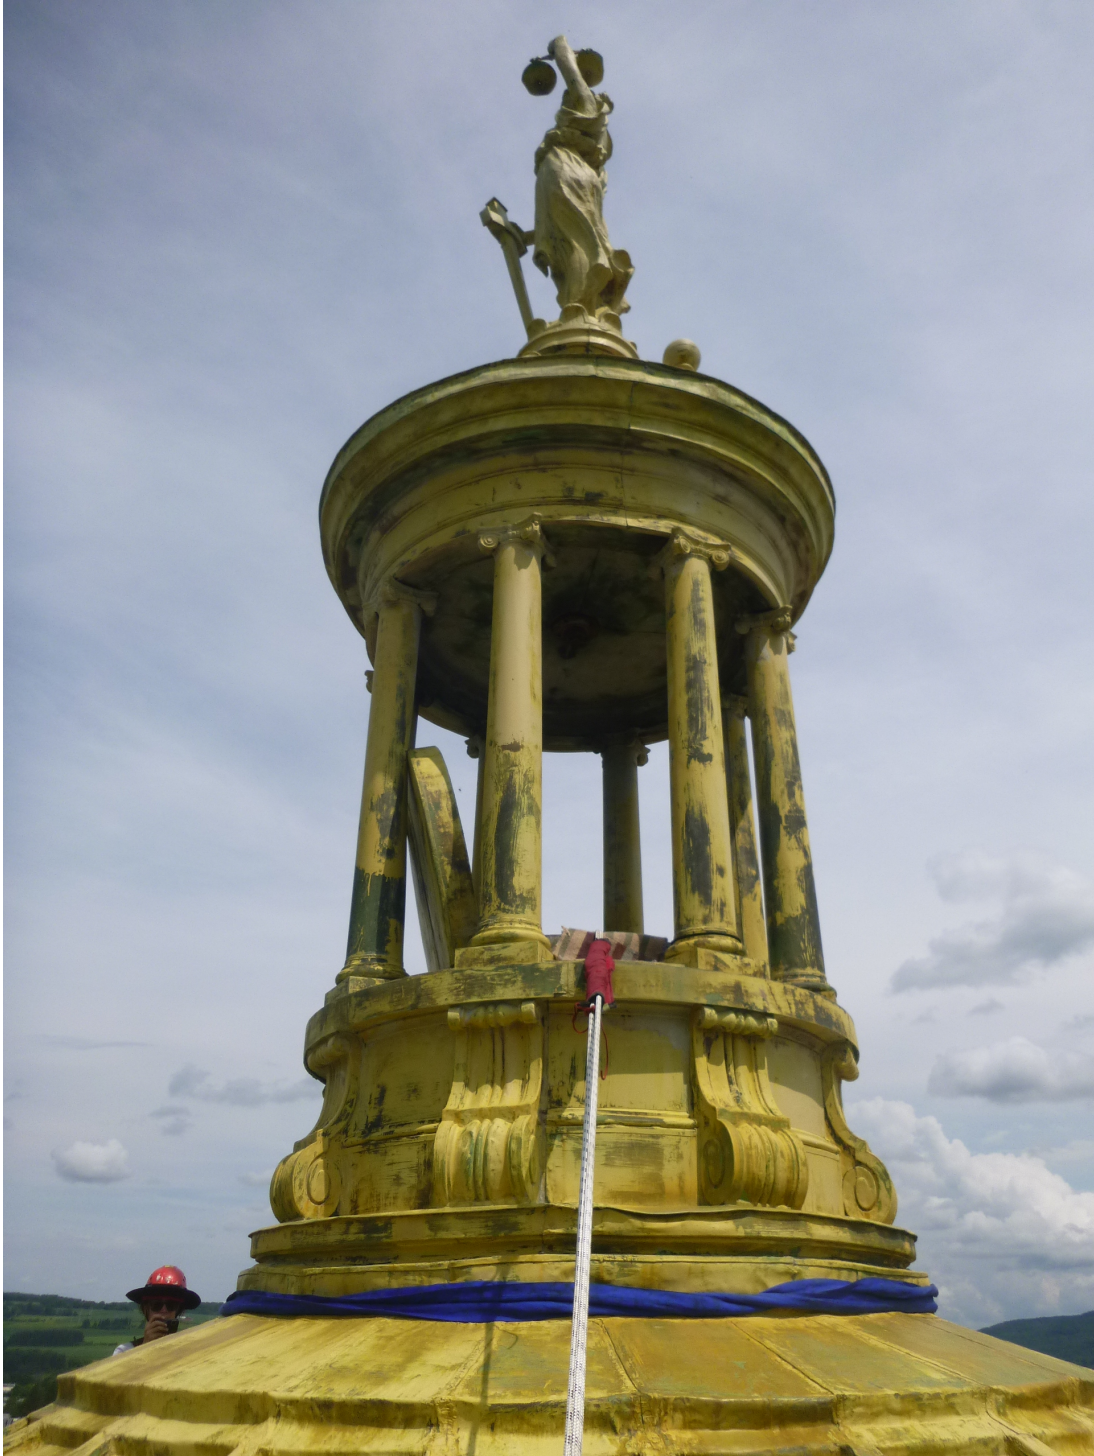
Figure 1: Cortland County Courthouse lantern and top of dome.

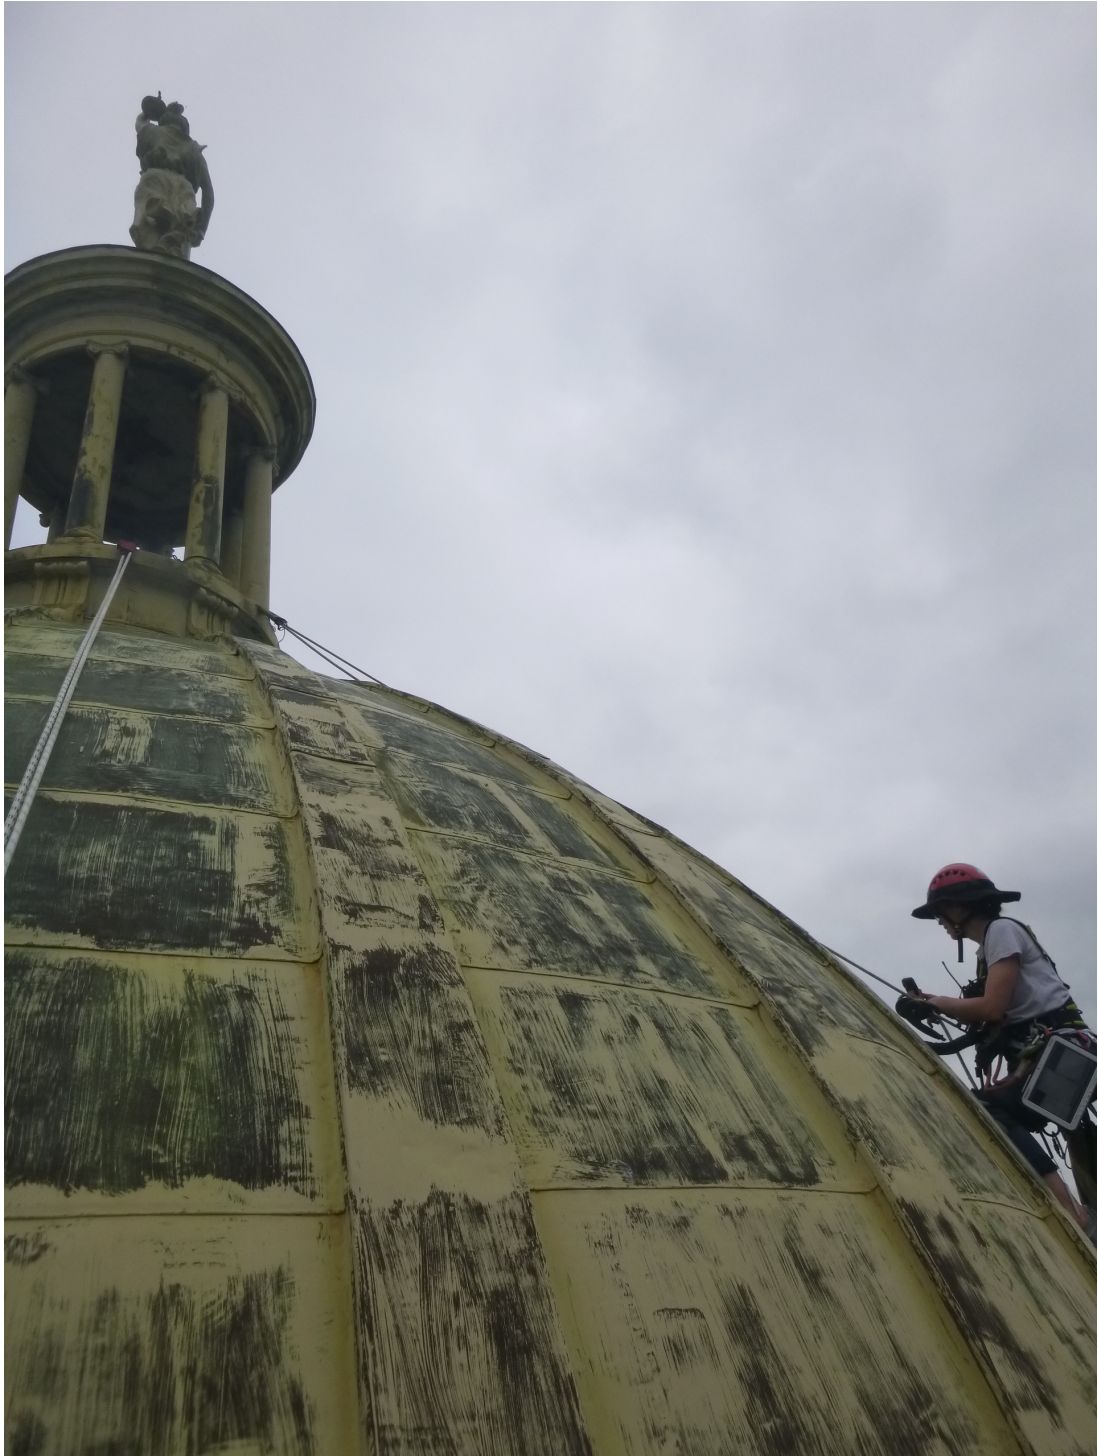
- The sheet copper cladding at the exterior of the dome and lantern is in fair to good condition. There are 24 facets of the sheet metal dome, consisting of sheet copper pans with the folded seams at the top and bottom seams of the pans and the sides turned up and covered by sheet copper rib covers. Sheet copper ornament at the dome and lantern includes brackets at the base of the dome, volutes at the base of the lantern, and eight columns with ionic capitals at the lantern. Measurements taken at several locations with digital calipers indicate that the copper is nominally between 0.031 and 0.040 inches thick, corresponding roughly to 24 oz. sheet copper. (See photographs 119-123,

Figure 2: Dome photograph showing pans and rib covers.

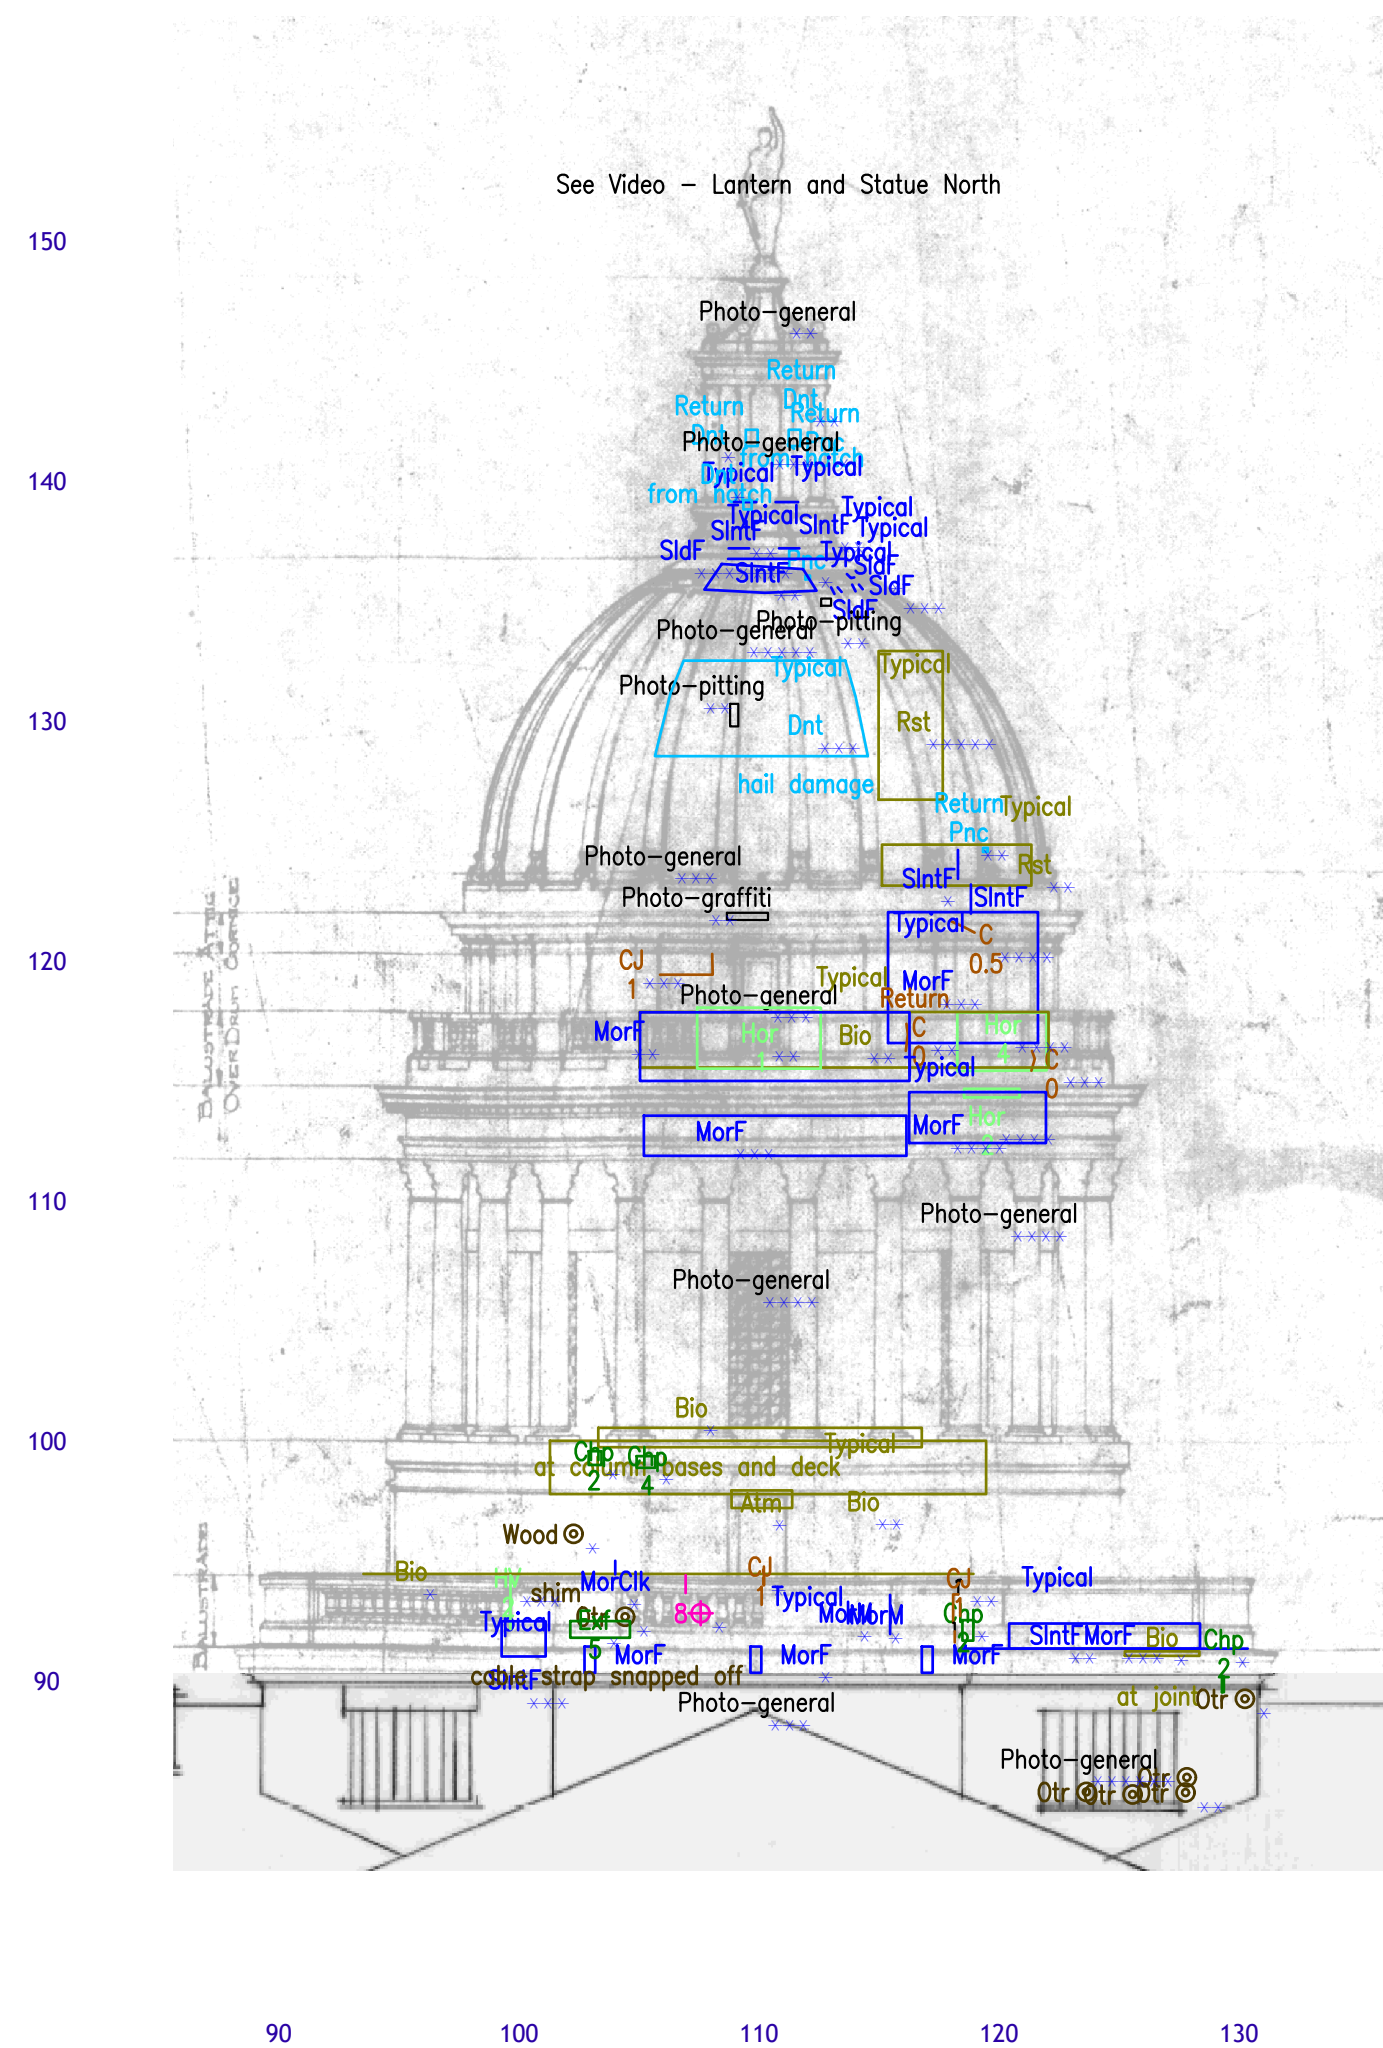
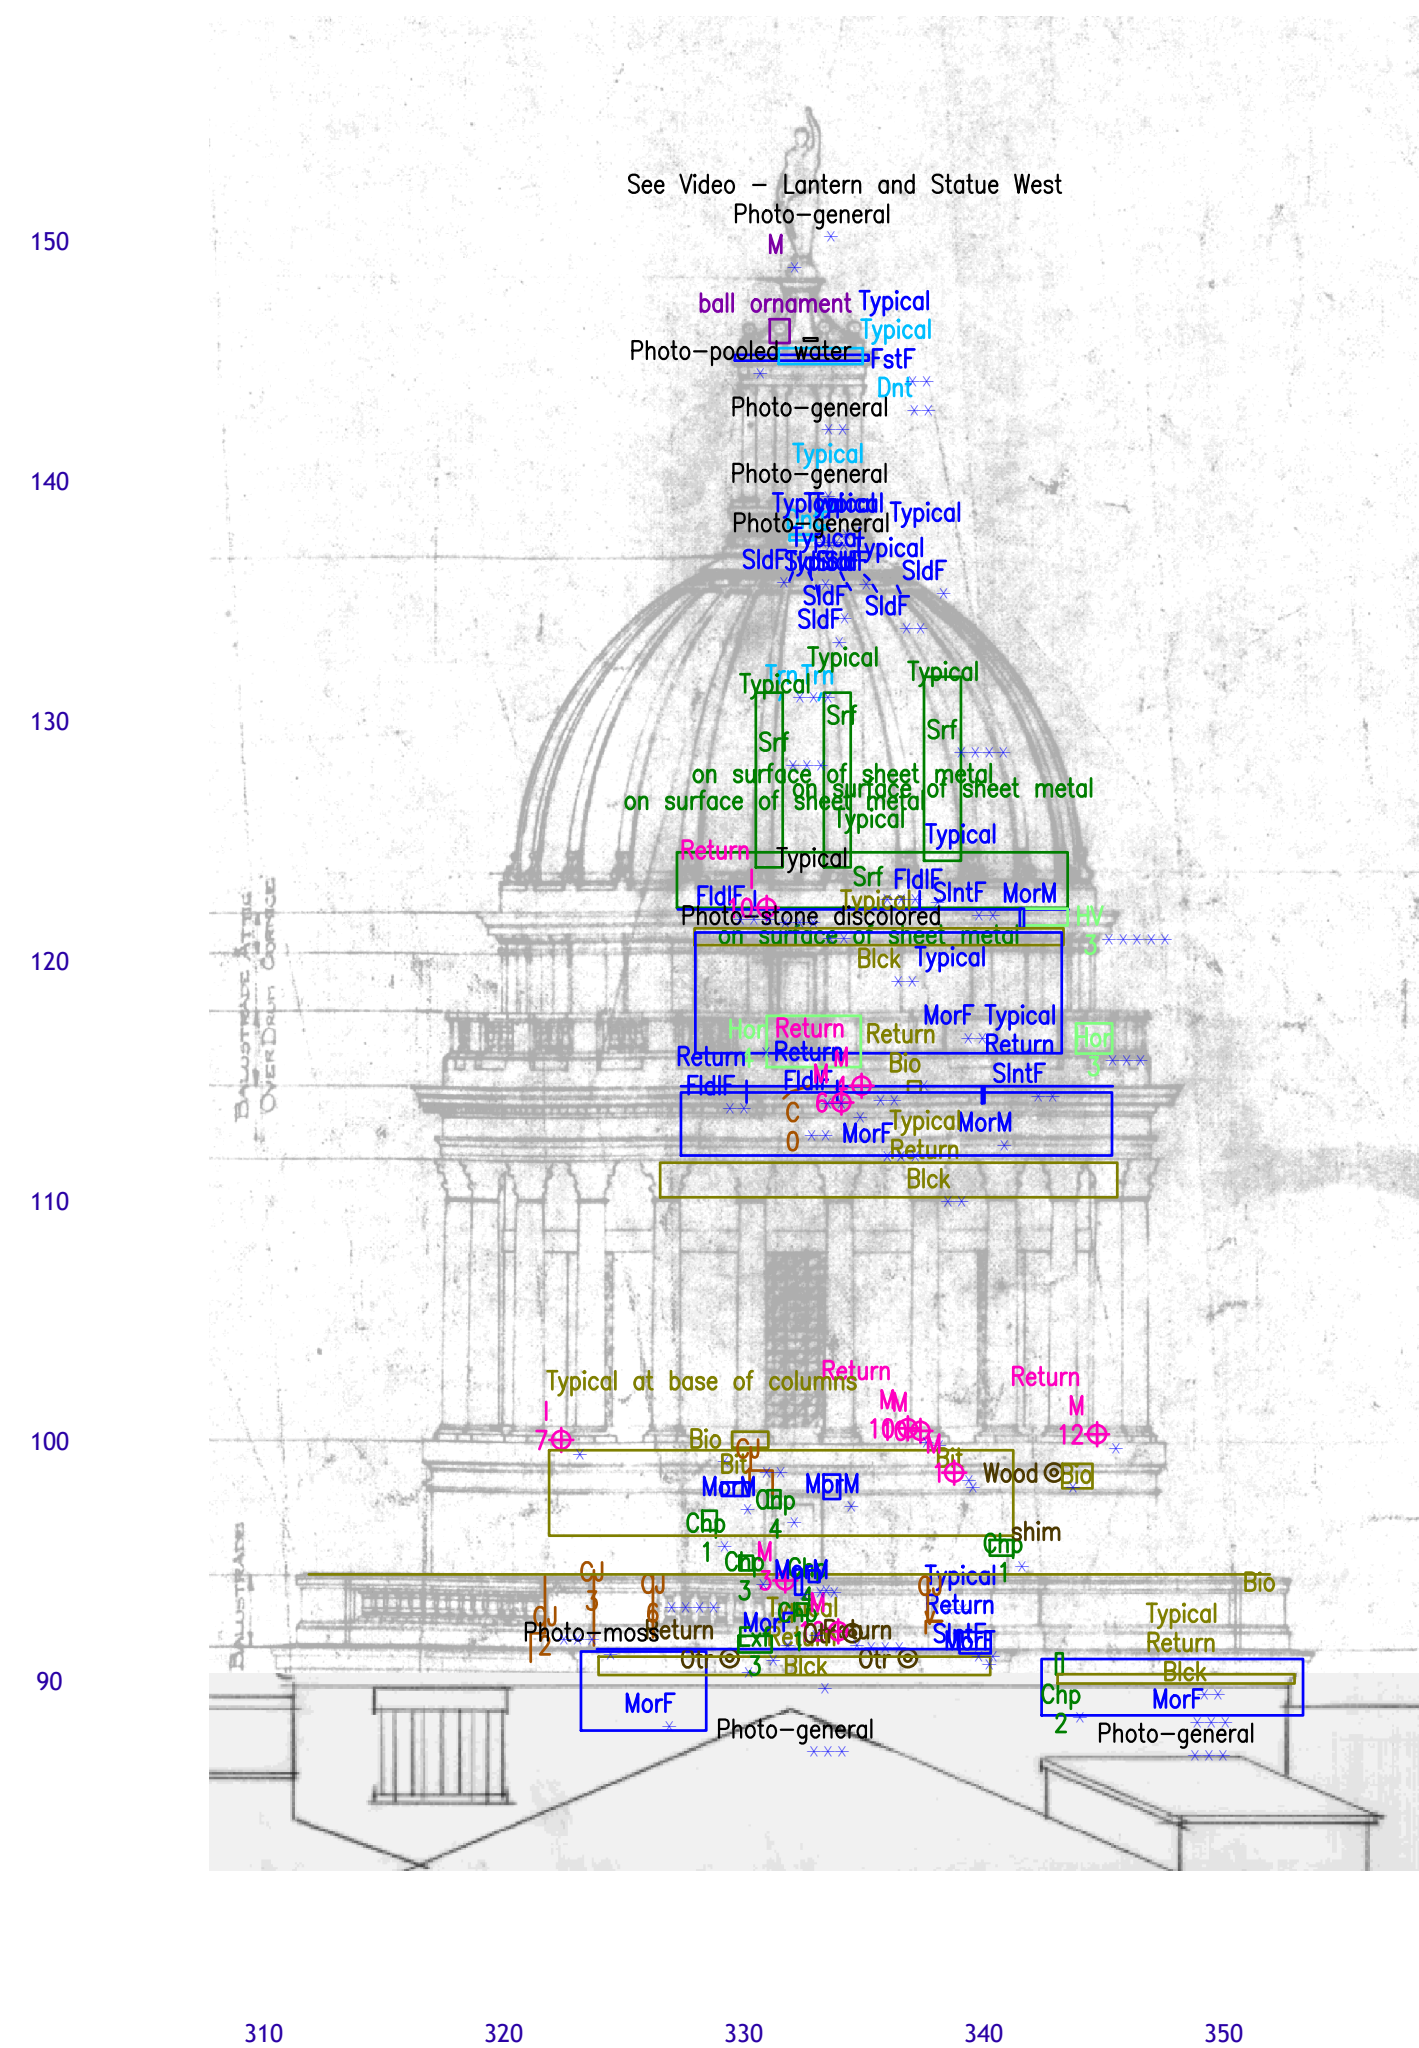
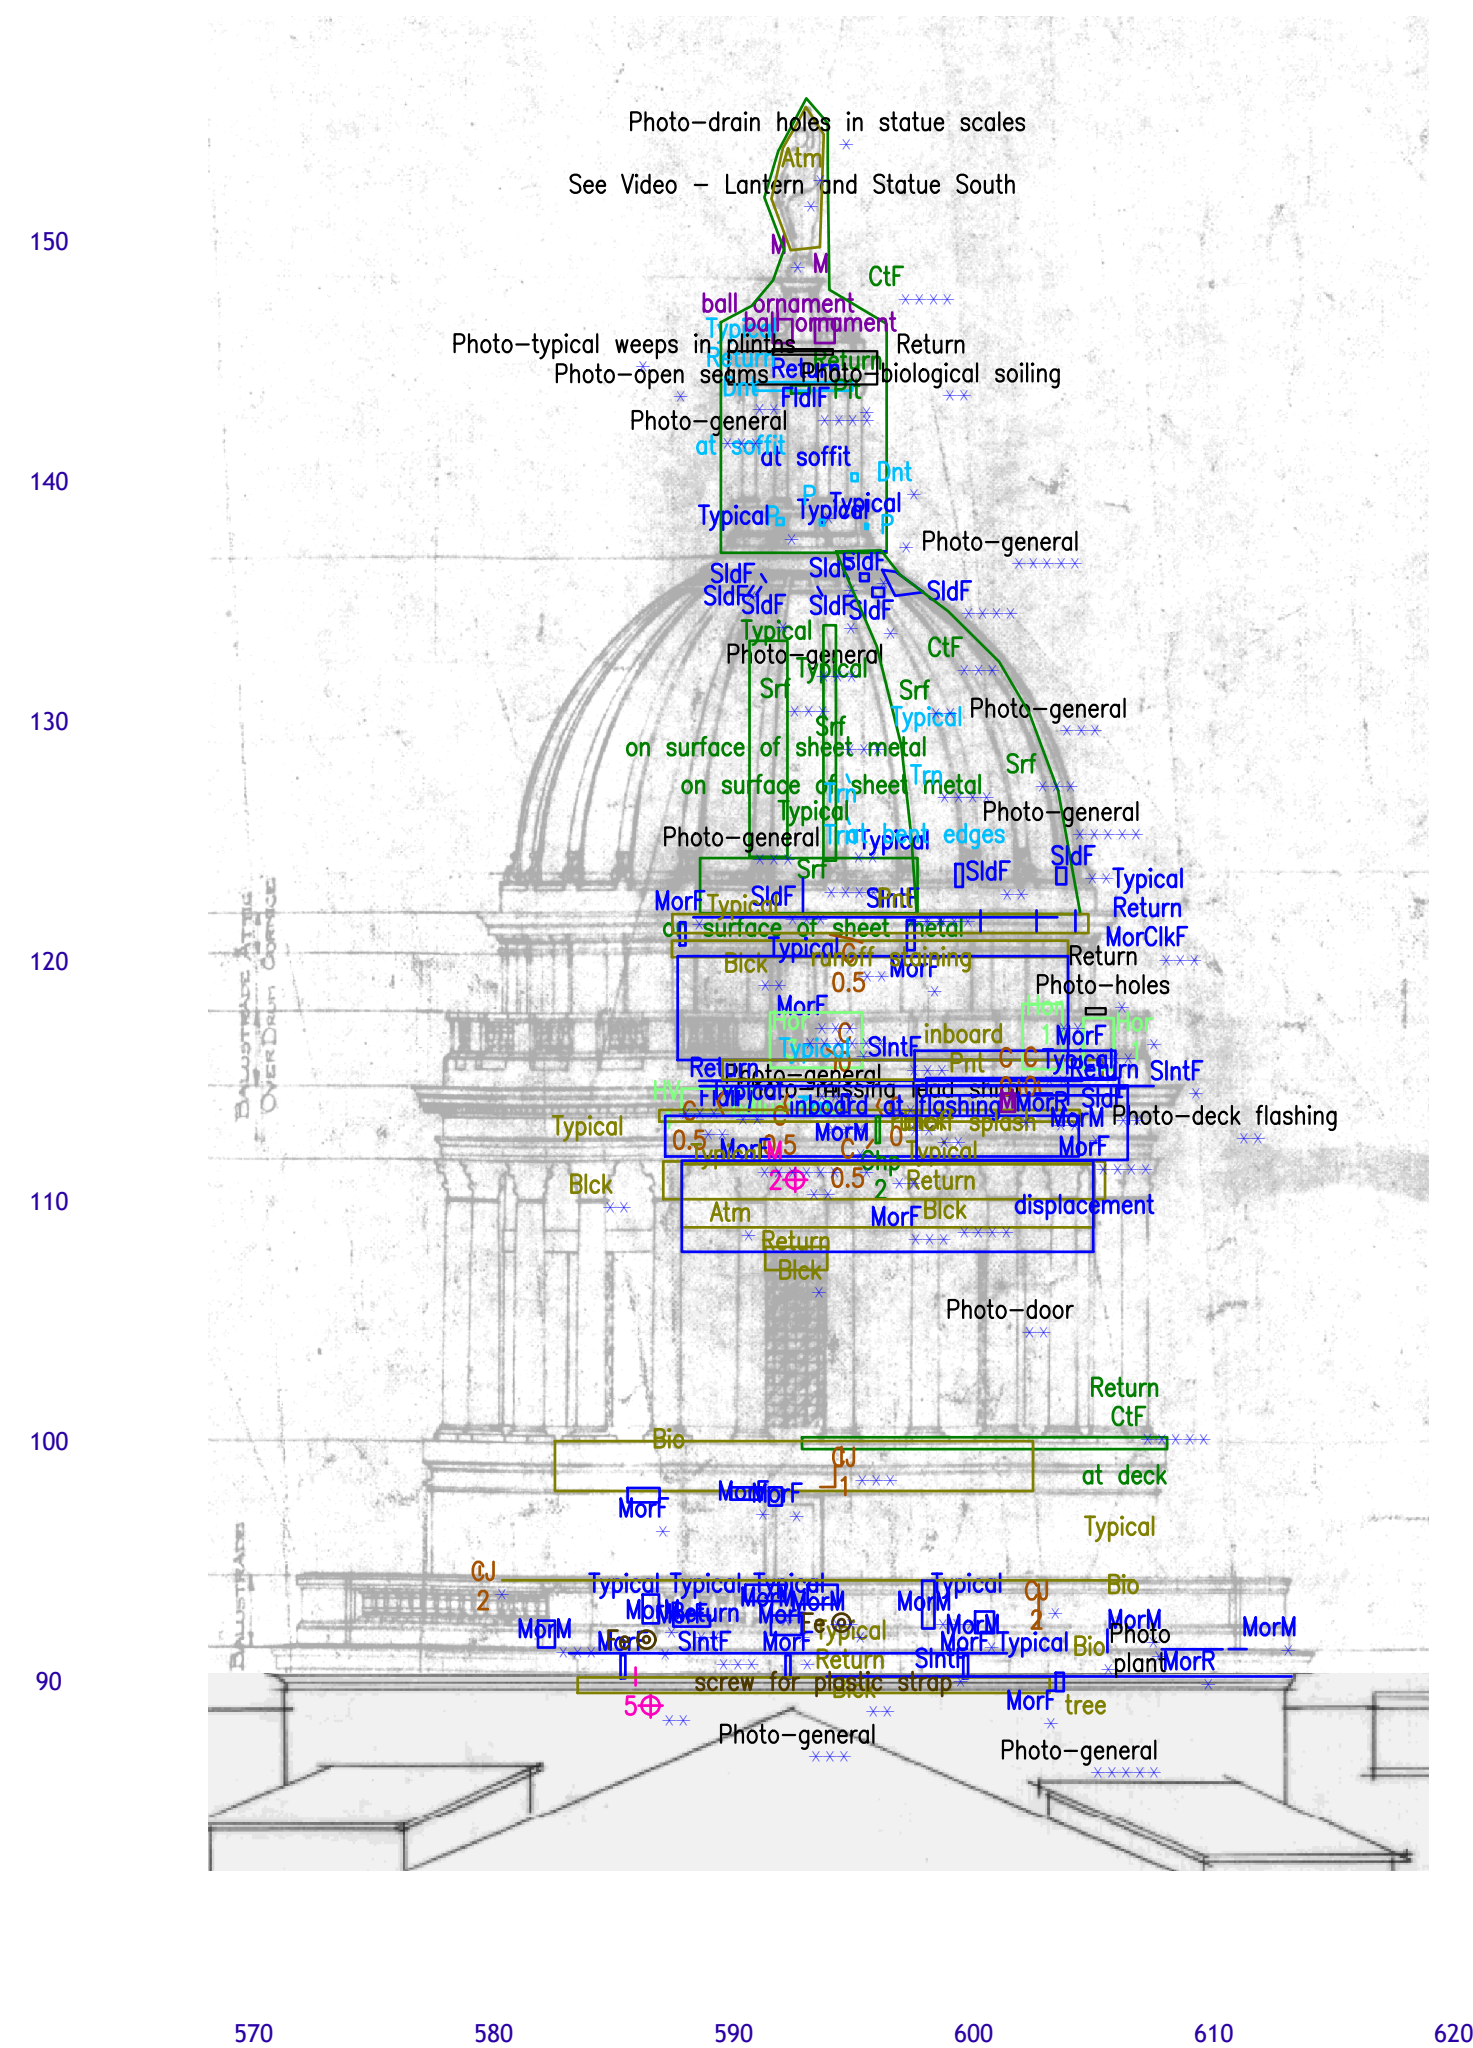
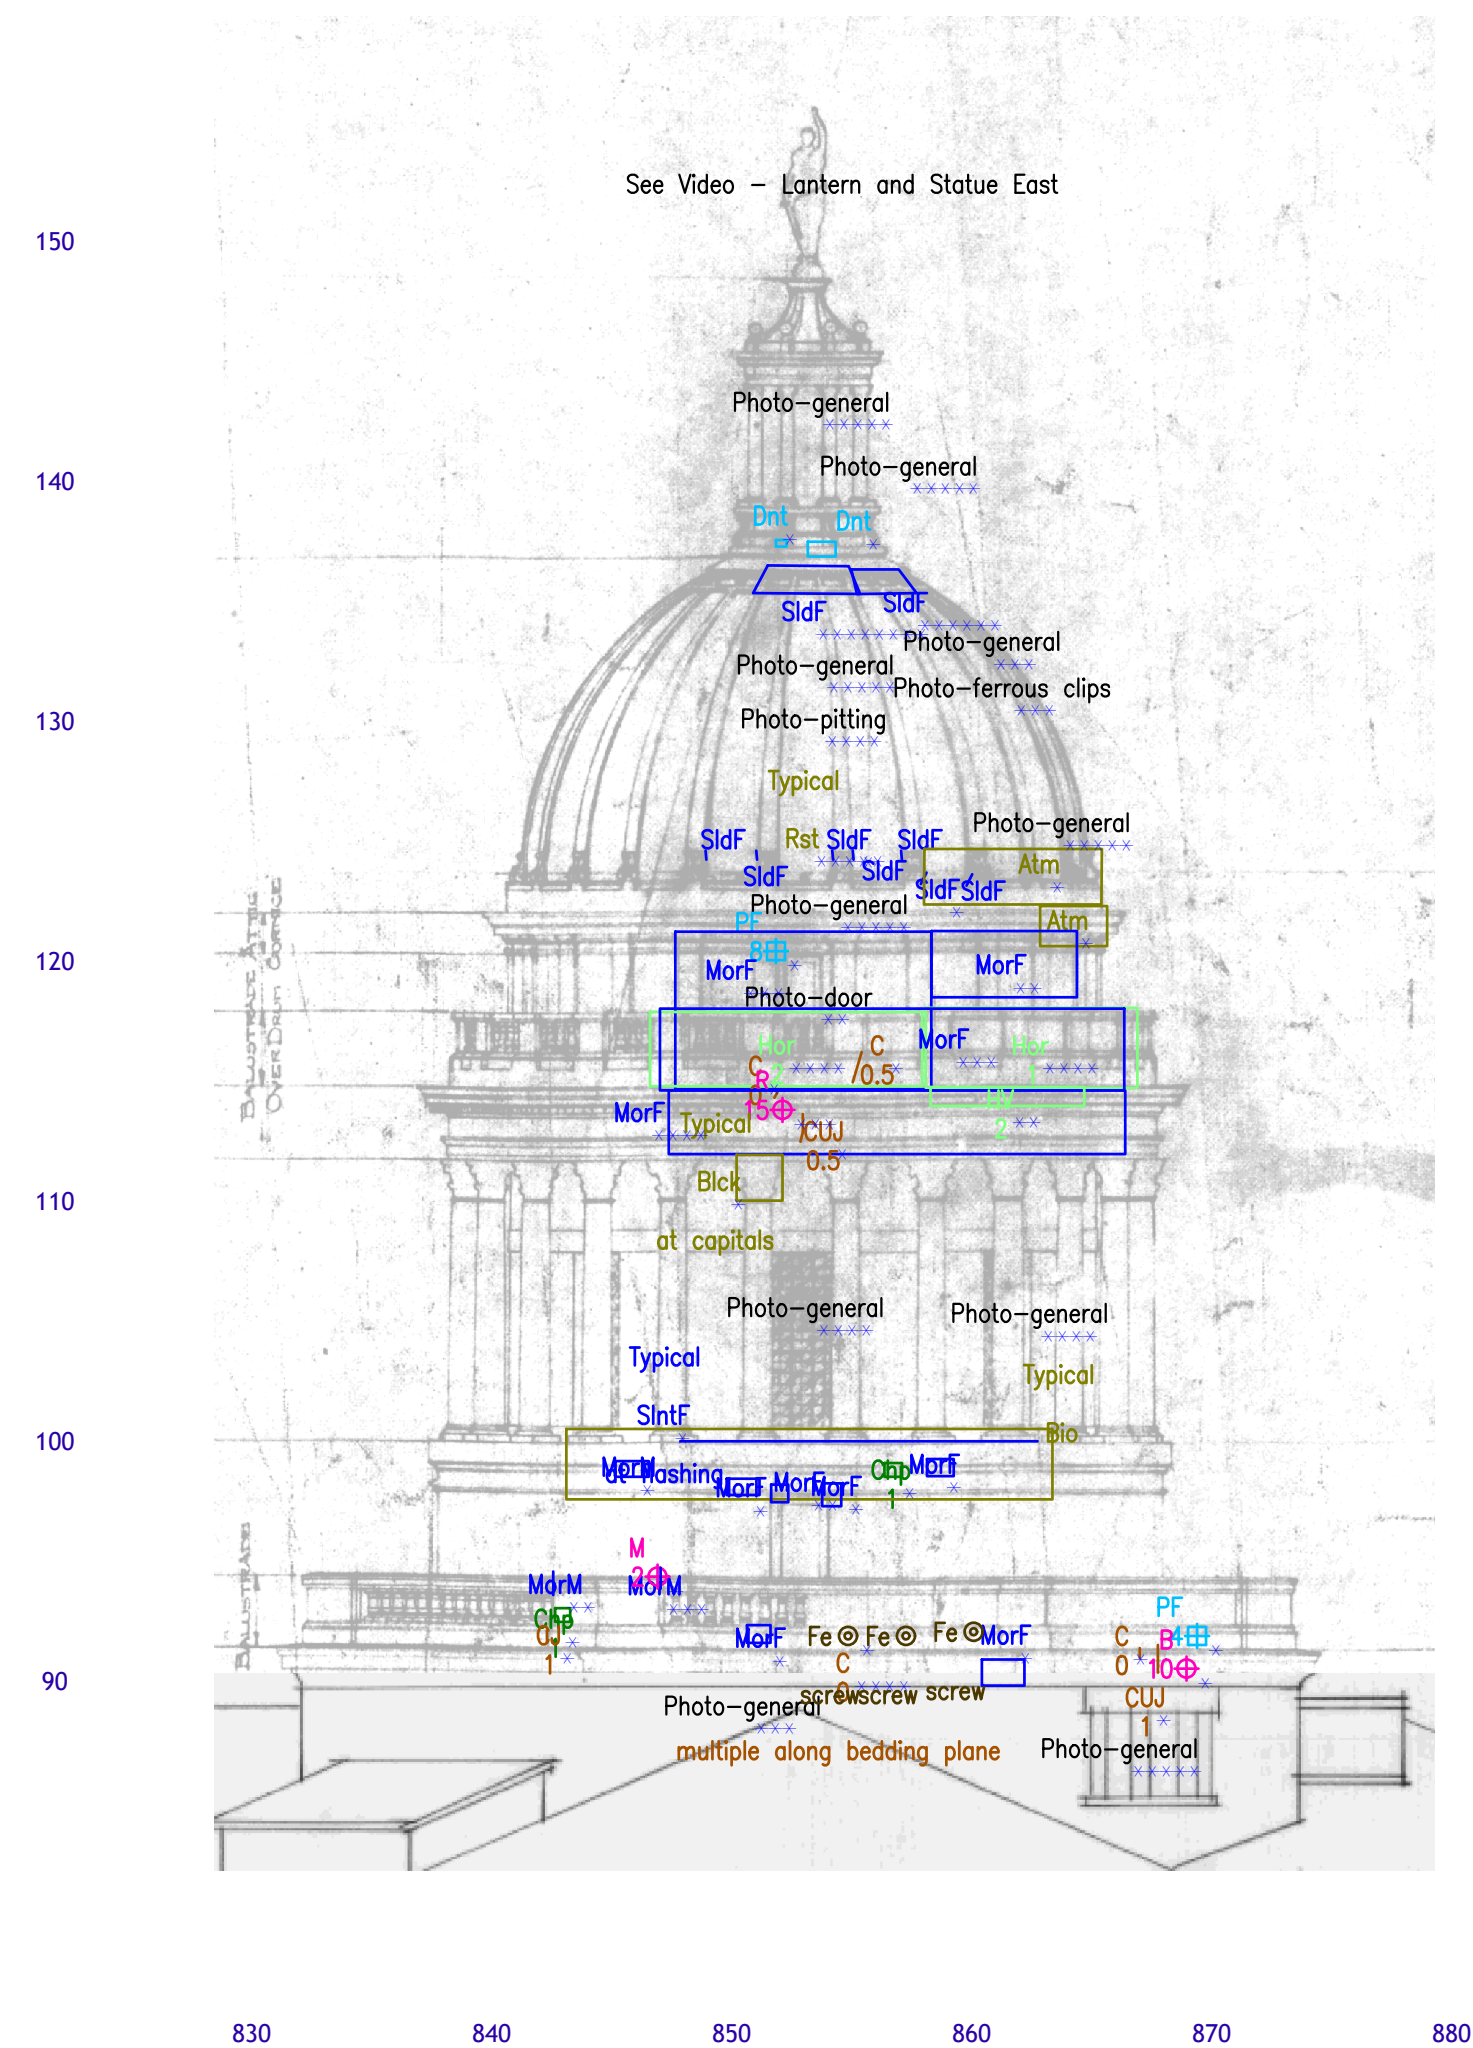
There are two drawing sheets included in the report. Sheet 1 contains the annotated elevations with the condition survey information. Sheet 2 has the locations of samples collected by Vertical Access for testing and analysis by others.

- A typical pattern of deterioration at the sheet metal dome is failed soldered seams (annotated “SldF” on the drawings) at the ribs covers where they meet the sheet copper lantern skirt near the top of the dome. The failed seams are typically three or four inches long. (See photographs 107-137, 595-136, 853-134).

- Some of the soldered seams at the base of the dome and the sheet metal covering over the stone cornices have also failed. (See photographs 592-122, 605-114).

- Nails popping out of the sheet copper frieze of the lantern were documented as a failed fastener seam (“FstF”). The failed fasteners were noted on the west side of the lantern. (See photographs 336-145).

- Several vertical folded seams at the base of dome were documented as failed (“FldF”). The seams exhibit minor separation between the sheet metal sections along the seam. (See photographs 329-122). The folded seams between the four pieces of sheet metal that make up the soffit of the lantern are also open and failed. (See photographs 593-143).

- Tears (“Trn”) in the sheet copper pans where they are turned up at the rib covers were noted at some locations. The tears are typically less than one inch long. Some pans are notched at the bend, reducing the likelihood of tearing. (See photographs 332-132, 598-127). The sheet copper counterflashing at the base of the outboard side of the upper balustrade is also torn. (See photographs 593-114).

- Punctures (“Pnc”) in the sheet metal were noted at a couple locations. One of the columns on the north side of the lantern has a puncture about one inch long where the open hatch cover hits the column. (See photographs 113-141). A puncture roughly 1/2 inch in diameter was also noted on the skyward-facing surface of one of the brackets on a northwest facet at the base of the dome. (See photographs 119-125).

- Dents (annotated “Dnt”) in the sheet metal were noted at several locations, particularly at the lantern. The sheet metal ornament at the cornice and base of the lantern exhibit typical denting. (See photographs 333-138, 852-138). Two columns on the north side of the lantern have dents where the open hatch cover hits the column. (See photographs 108-142, 112-143). The sheet metal panels at the soffit of the lantern also exhibits denting. (See photographs 590-144). Shallow dents on the north side of the dome were also noted, perhaps evidence of hail damage. (See photographs 112-129).

- Rust staining on the surface of the sheet copper at the dome is typical. The pattern of the rust staining in streaks along the rib covers and at the bottom edges of some of the pans indicate that the staining may be from corrosion of ferrous fasteners or structure under the sheet copper cladding. (See photographs 116-130, 853-125).
- All of the sheet copper has been painted with a yellow coating. The paint may cover some conditions that were not documented during the investigation. The yellow paint coating has failed, with weathering, chalking and loss of binder typical. Flaking and peeling of the paint from the copper substrate is less common. (See photographs 596-148, 599-133).

- Horizontal displacement (“Hor” on the annotated drawings) of sections of the stone balustrades at the upper setback level was noted on all sides of the building. The displacement measures up to 1/2 inch and is typically outward away from the building. At some locations the displaced units include the piers between the balustrade sections and at some locations just the balustrade sections with balusters are displaced. (See photographs 110-117, 592-117, 603-118, 862-116).

- Cracks between hairline and 1/16 inch in width were noted at cornice units directly below the base of the dome, below the upper balustrade level, and above the peristyle. The cracks typically run vertically or diagonally across the units and are in single units (annotated “C” on the drawings), rather than through multiple units. (See photographs 119-121, 602-116, 855-90).

- Hairline cracks were also documented at both balustrade levels. The cracks are between hairline and 1/16 inch in width. Some of the cracks extend into multiple units (“CU”) or through mortar joints (“CJ”). (See photographs 595-99, 842-92, 854-113).

- Several spalls were identified during the investigation. Spalls were designated with one of the following codes: “B” for bonded in position with either mortar or sealant, “I” for incipient spalls that have not fully formed, “M” if missing at the time of the survey, or “R” for spalls that were removed by Vertical Access during the survey. Most of the documented spalls measure between 5 and 10 square inches. (See photographs 339-99, 337-100,

- Areas of chipped stone at the edges of units were noted at the lower balustrade level and frieze units at the upper part of the drum. The chipping is typically 1/4 to 1/2 inch in depth. (See photographs 103-99, 332-92, 596-111).

- All of the sealant at the masonry has failed. Sealant is found in reglet joints in the skyward-facing surfaces of the cornice units where the sheet metal cornice covers terminate. At least two types of sealant are found in the reglet joints, both of which appear to be urethane. (See photographs 339-92, 341-115).

- In general, the mortar at the drum is in good condition. Areas of failed mortar were documented at both balustrade levels, at the attic level, and at the entablature above the peristyle. At these areas, there is both sound and failed mortar. The failed mortar at the upper balustrade level exhibits erosion. (See photographs 339-117, 861-119). The failed mortar at the attic level, the lower balustrade level and the peristyle entablature is cracked and separated from the stone. (See photographs 125-92, 326-89, 591-112, 846-113).

- The coating at the deck of the peristyle level has failed in some areas. The coating is applied to the skyward-facing surfaces of the deck, including the column plinths. The coating at the deck drain at the southeast side of this level has torn allowing water ingress around the drain. (See photographs 606-101).
