# Public Works Committee

## Special Meeting

**AGENDA ITEM NO. 3 – Award Courthouse Dome Repair and Painting**

Vertical Access LLC (VA) was retained by Bell & Spina, P.C. to perform a hands-on and close visual inspection of the exterior of the sheet metal-clad dome and masonry drum of the Cortland County Courthouse in Cortland, NY. The purpose of the survey was to document existing conditions in order to assist the project team with preparation of repair recommendations. As part of the investigative work, VA documented representative and notable conditions with digital photographs and video files hyperlinked to annotated conditions drawings.

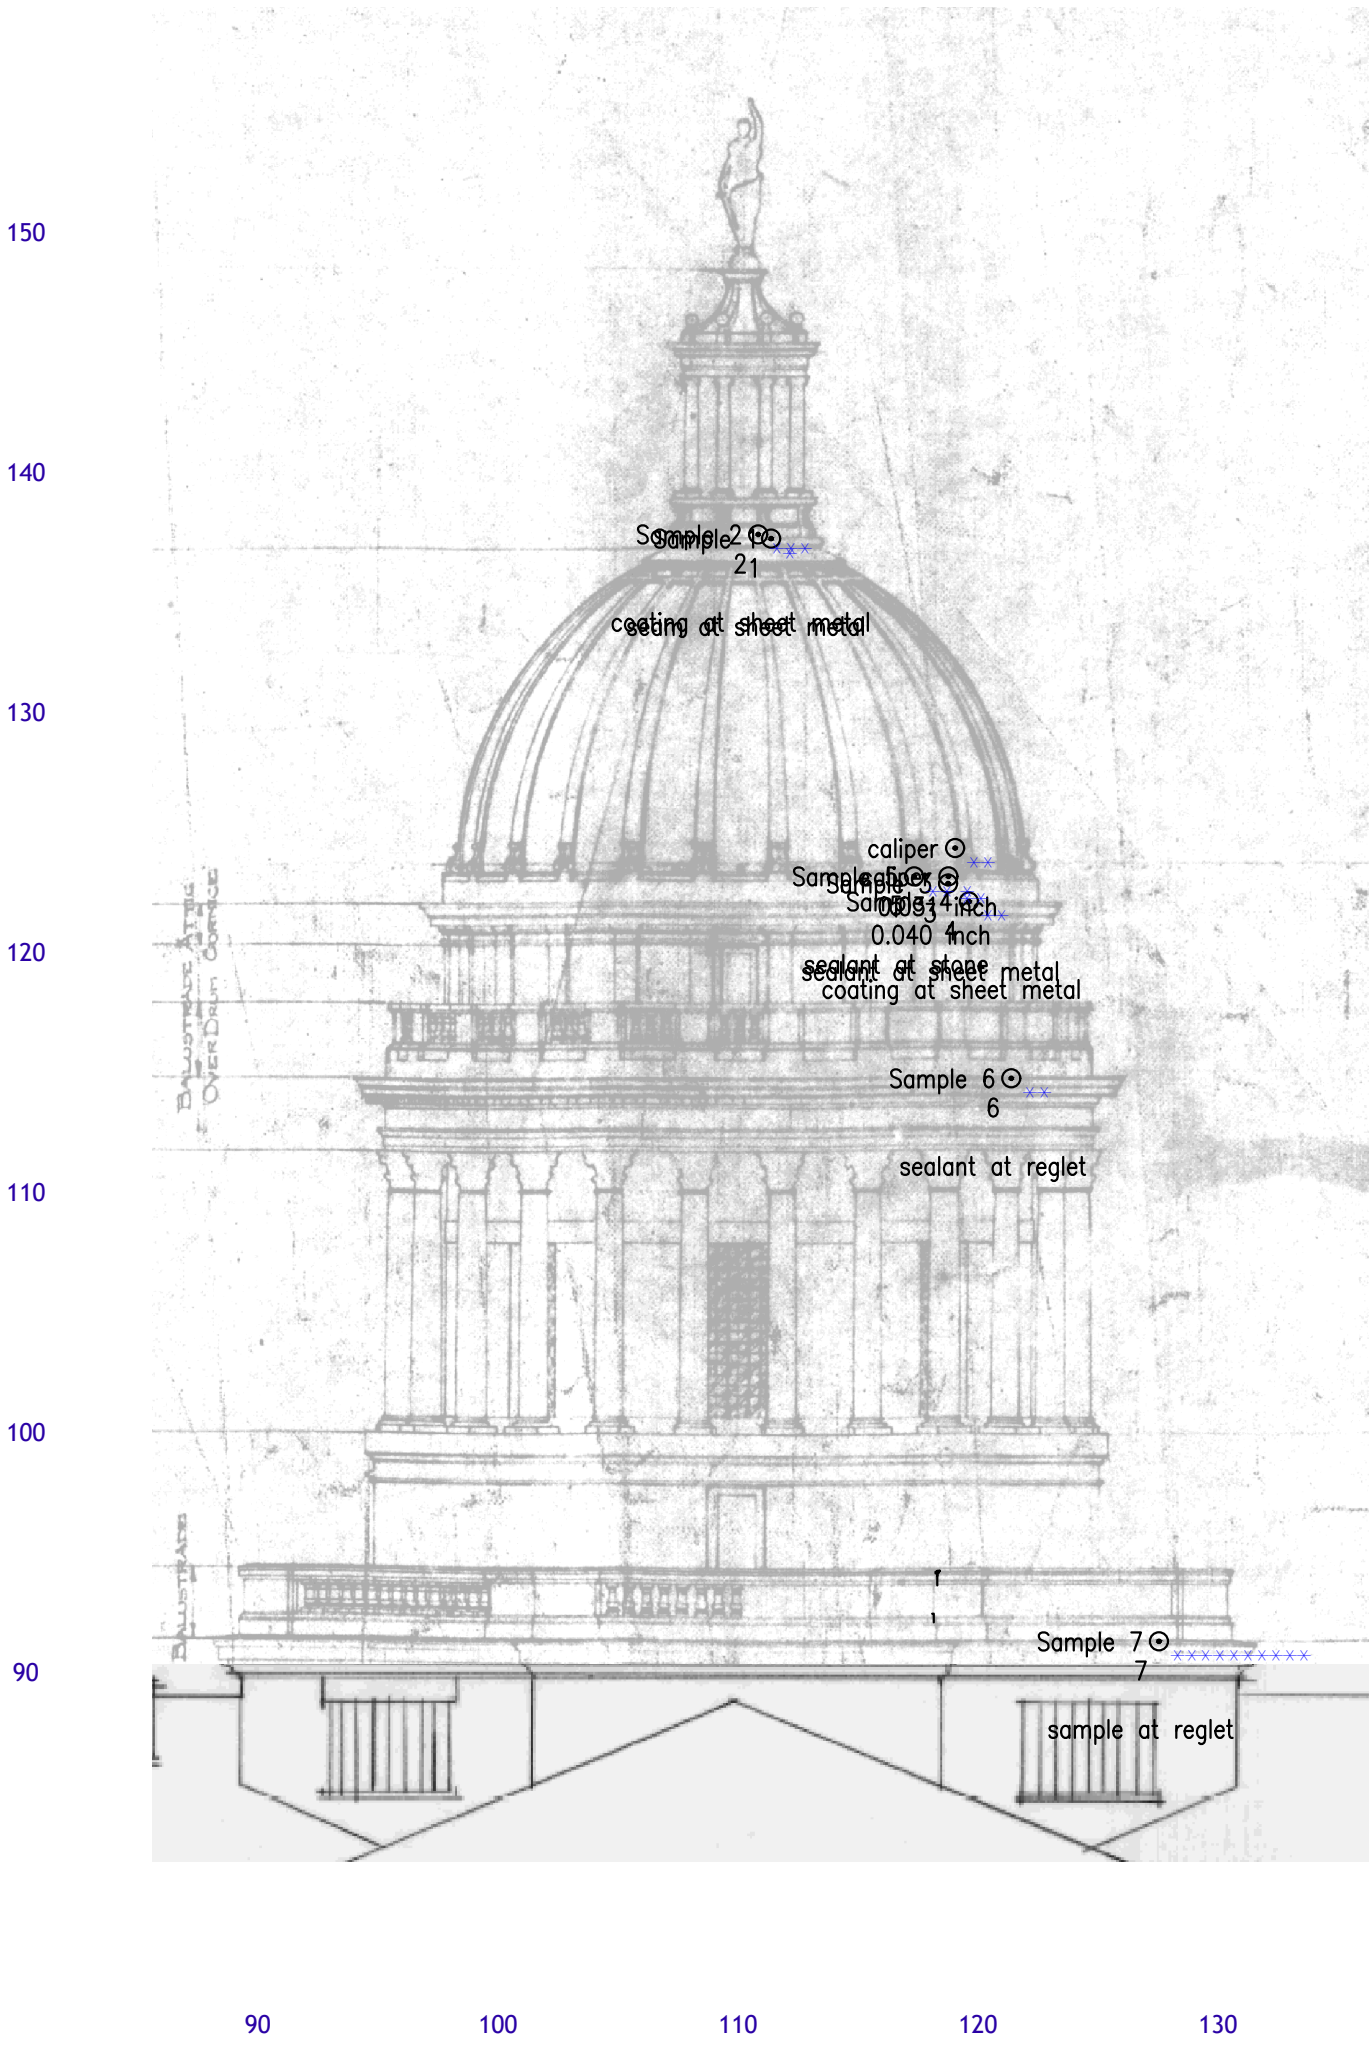
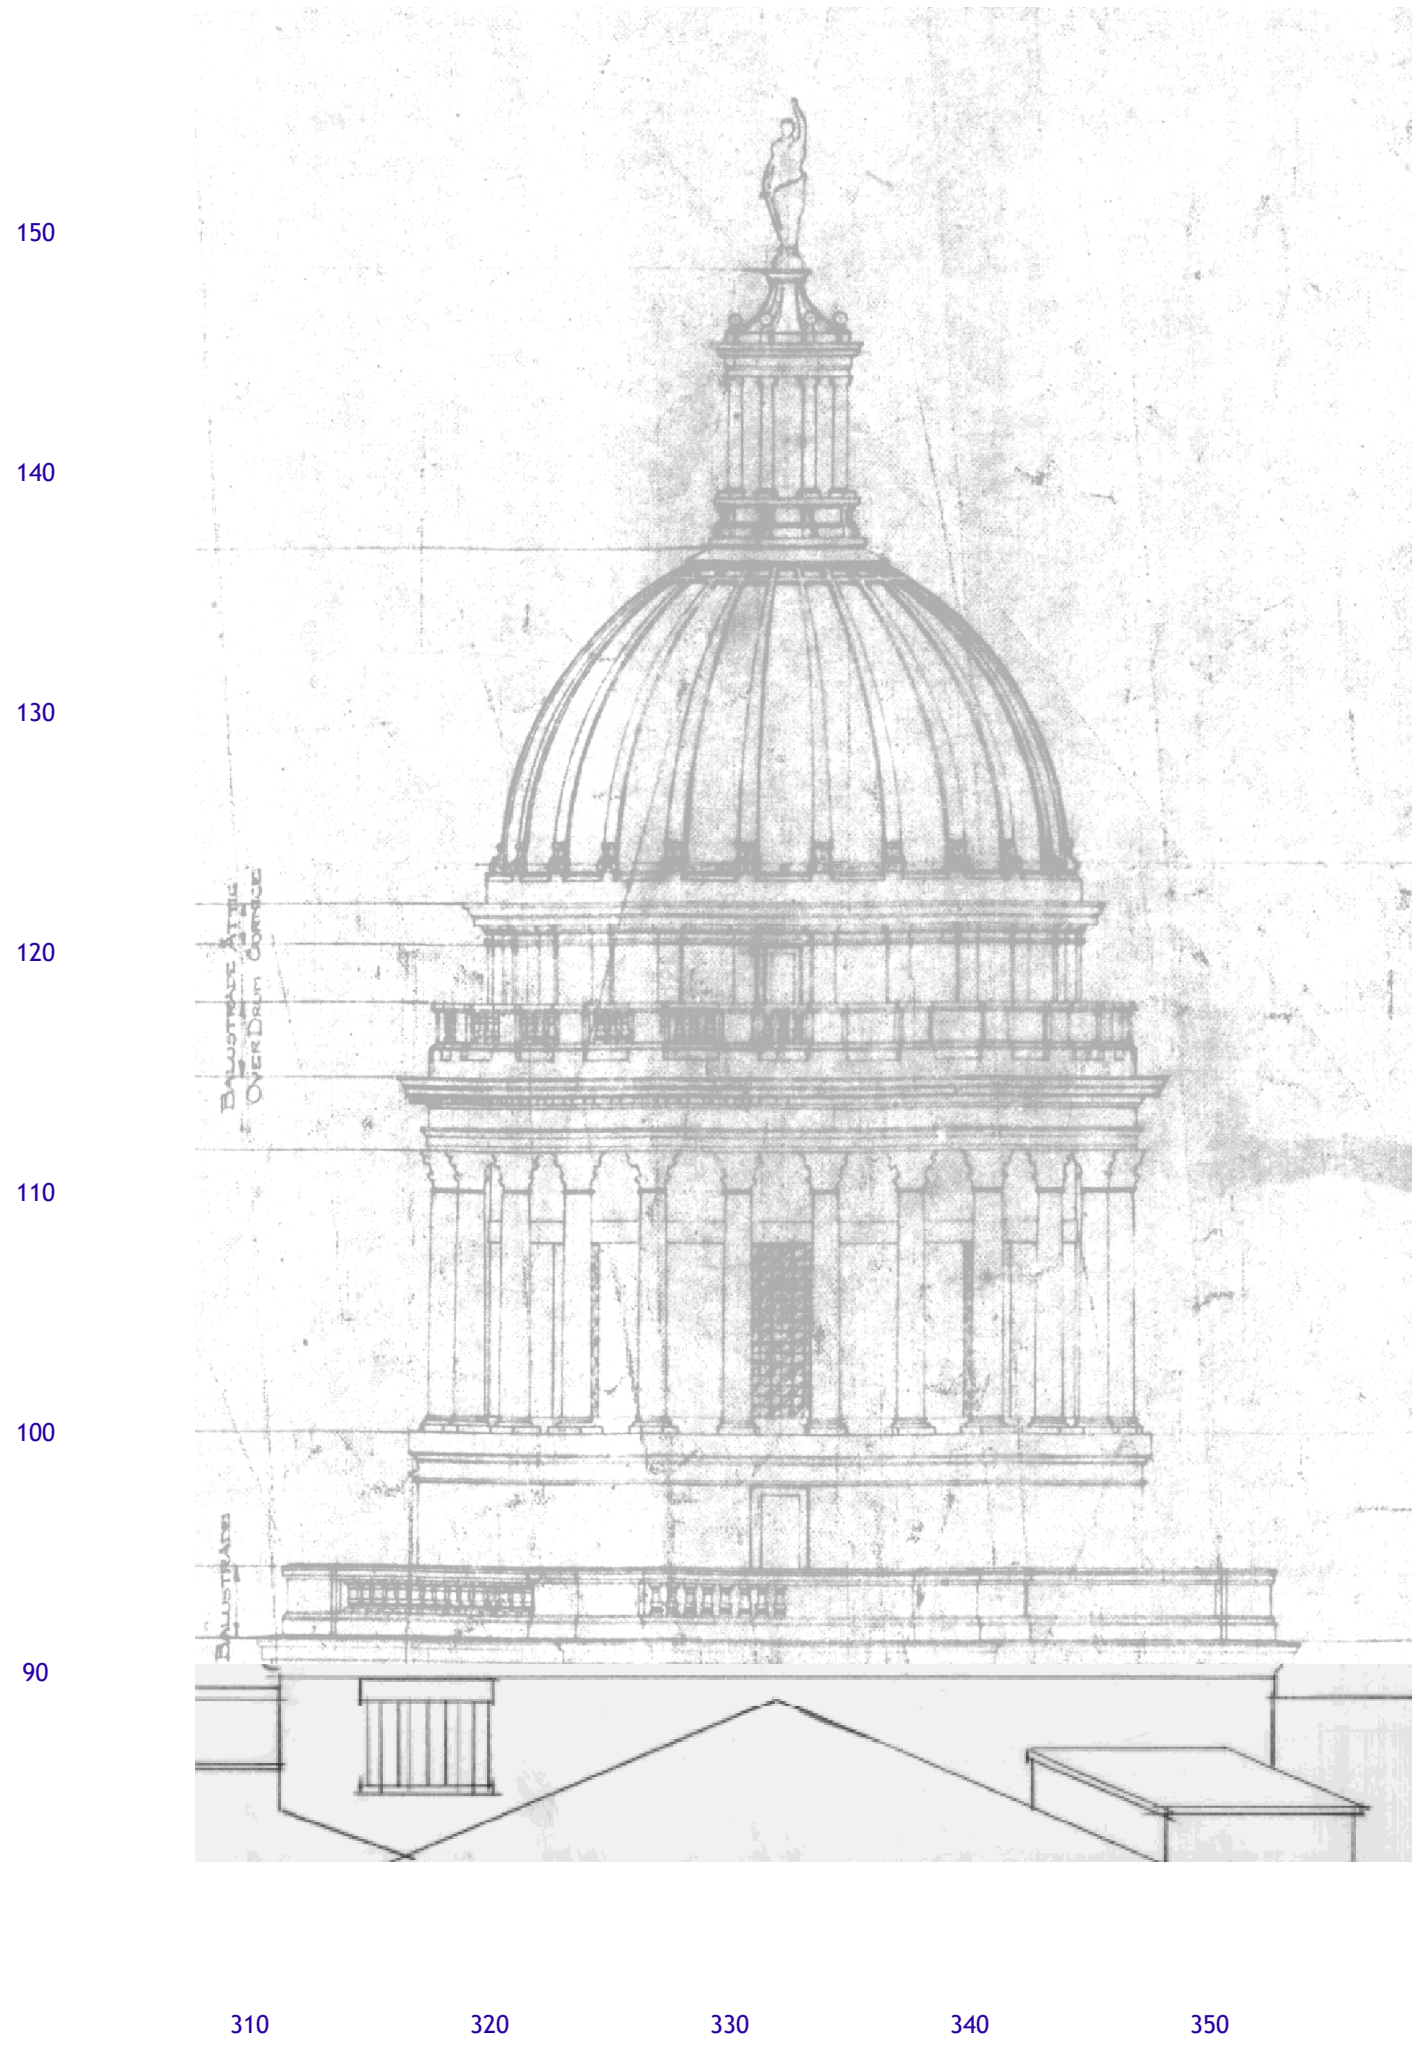
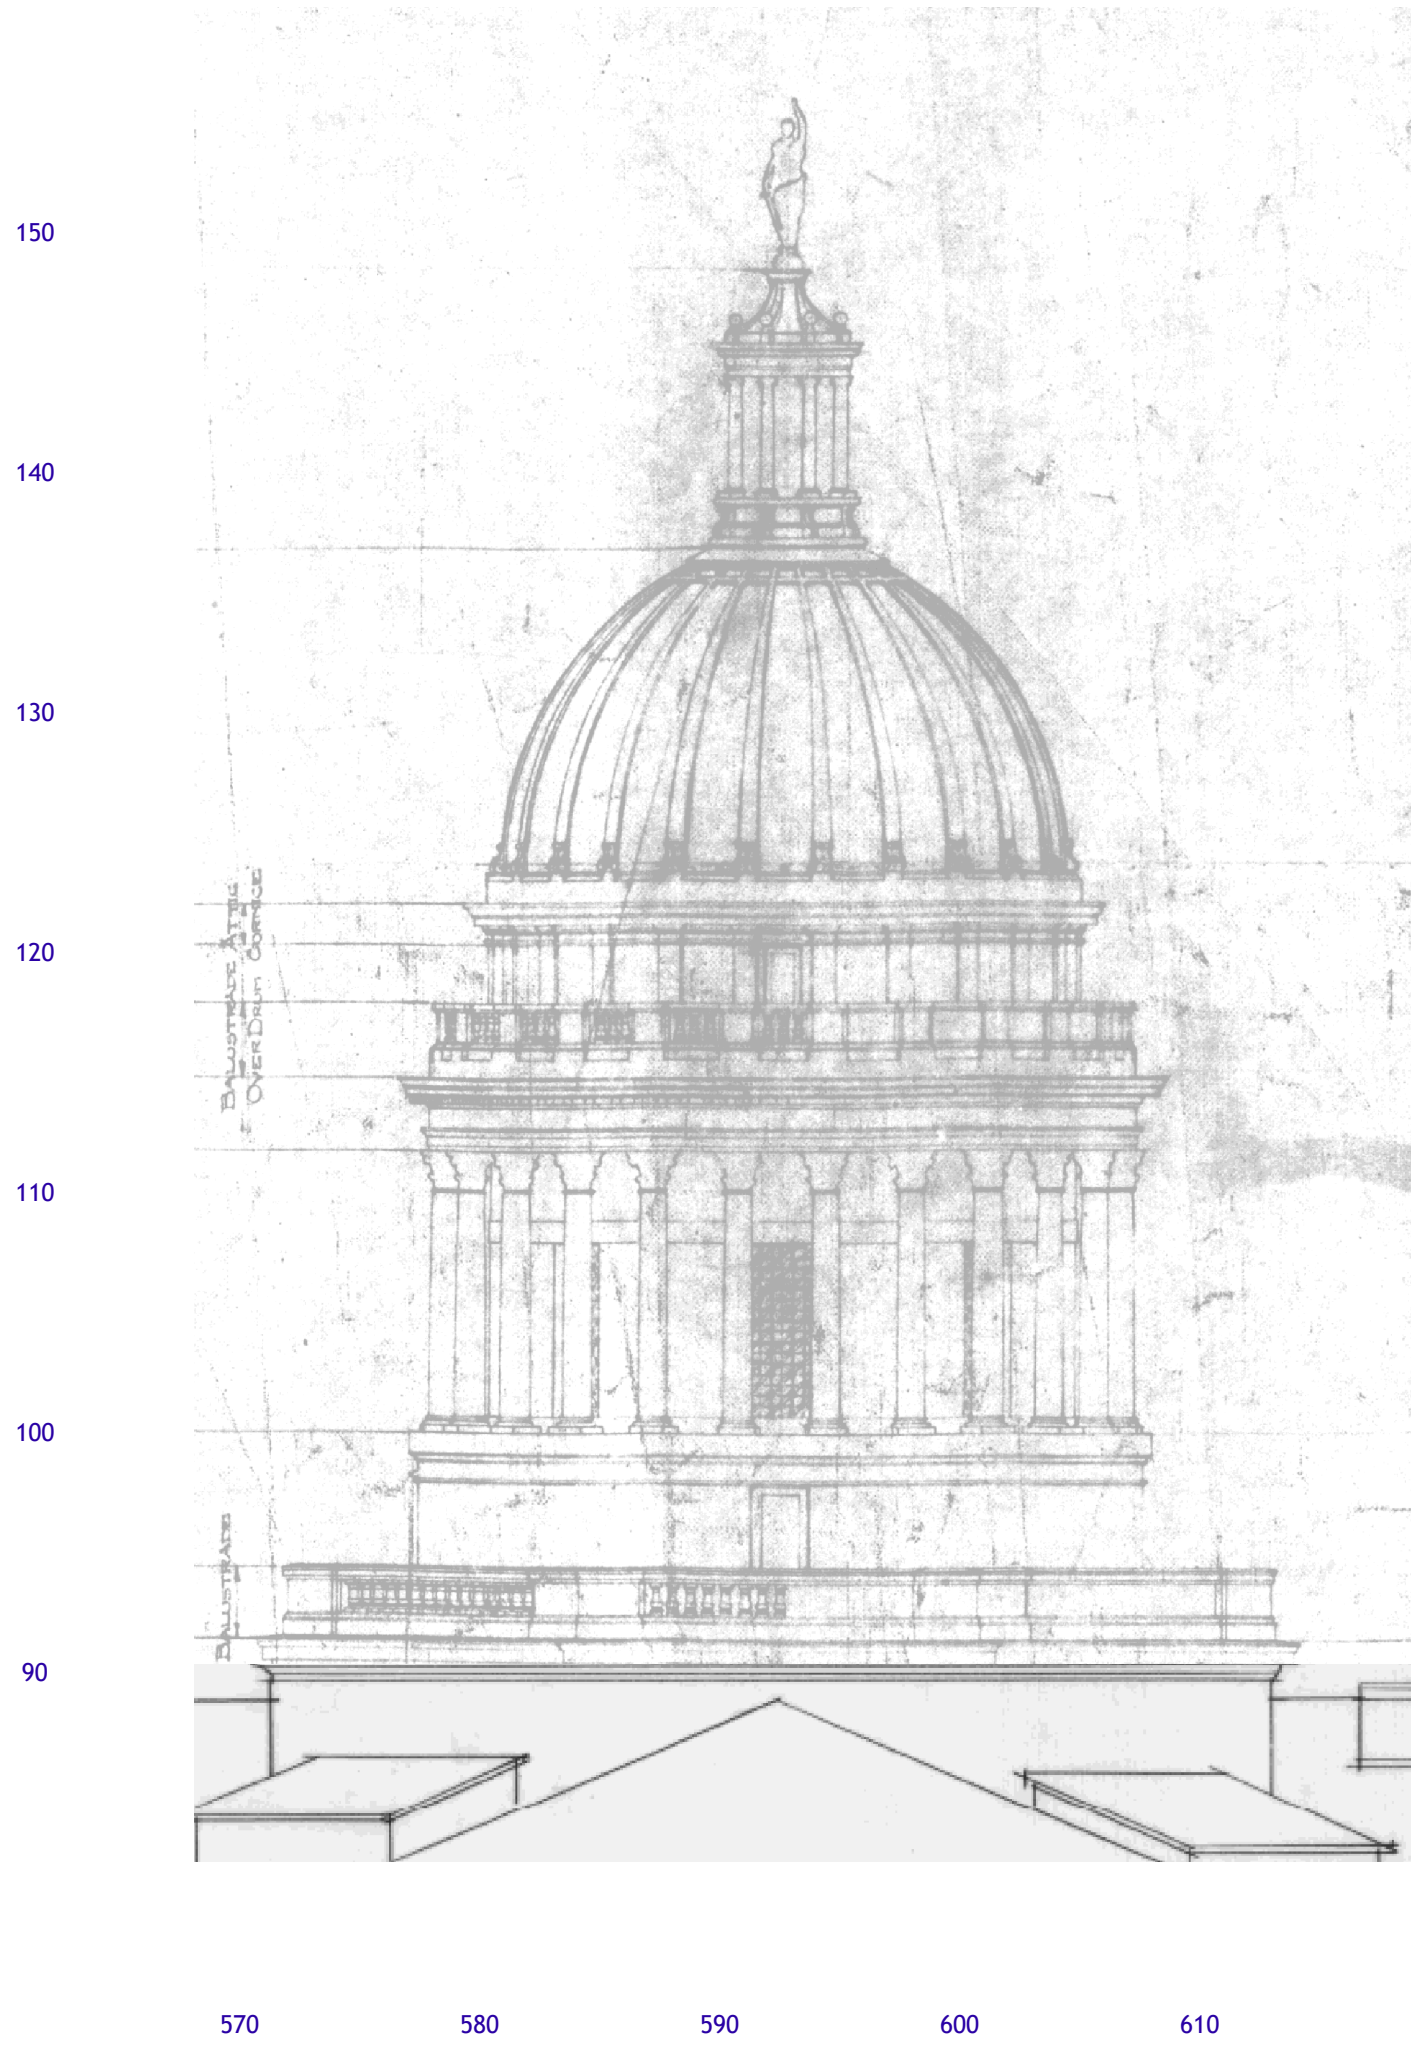
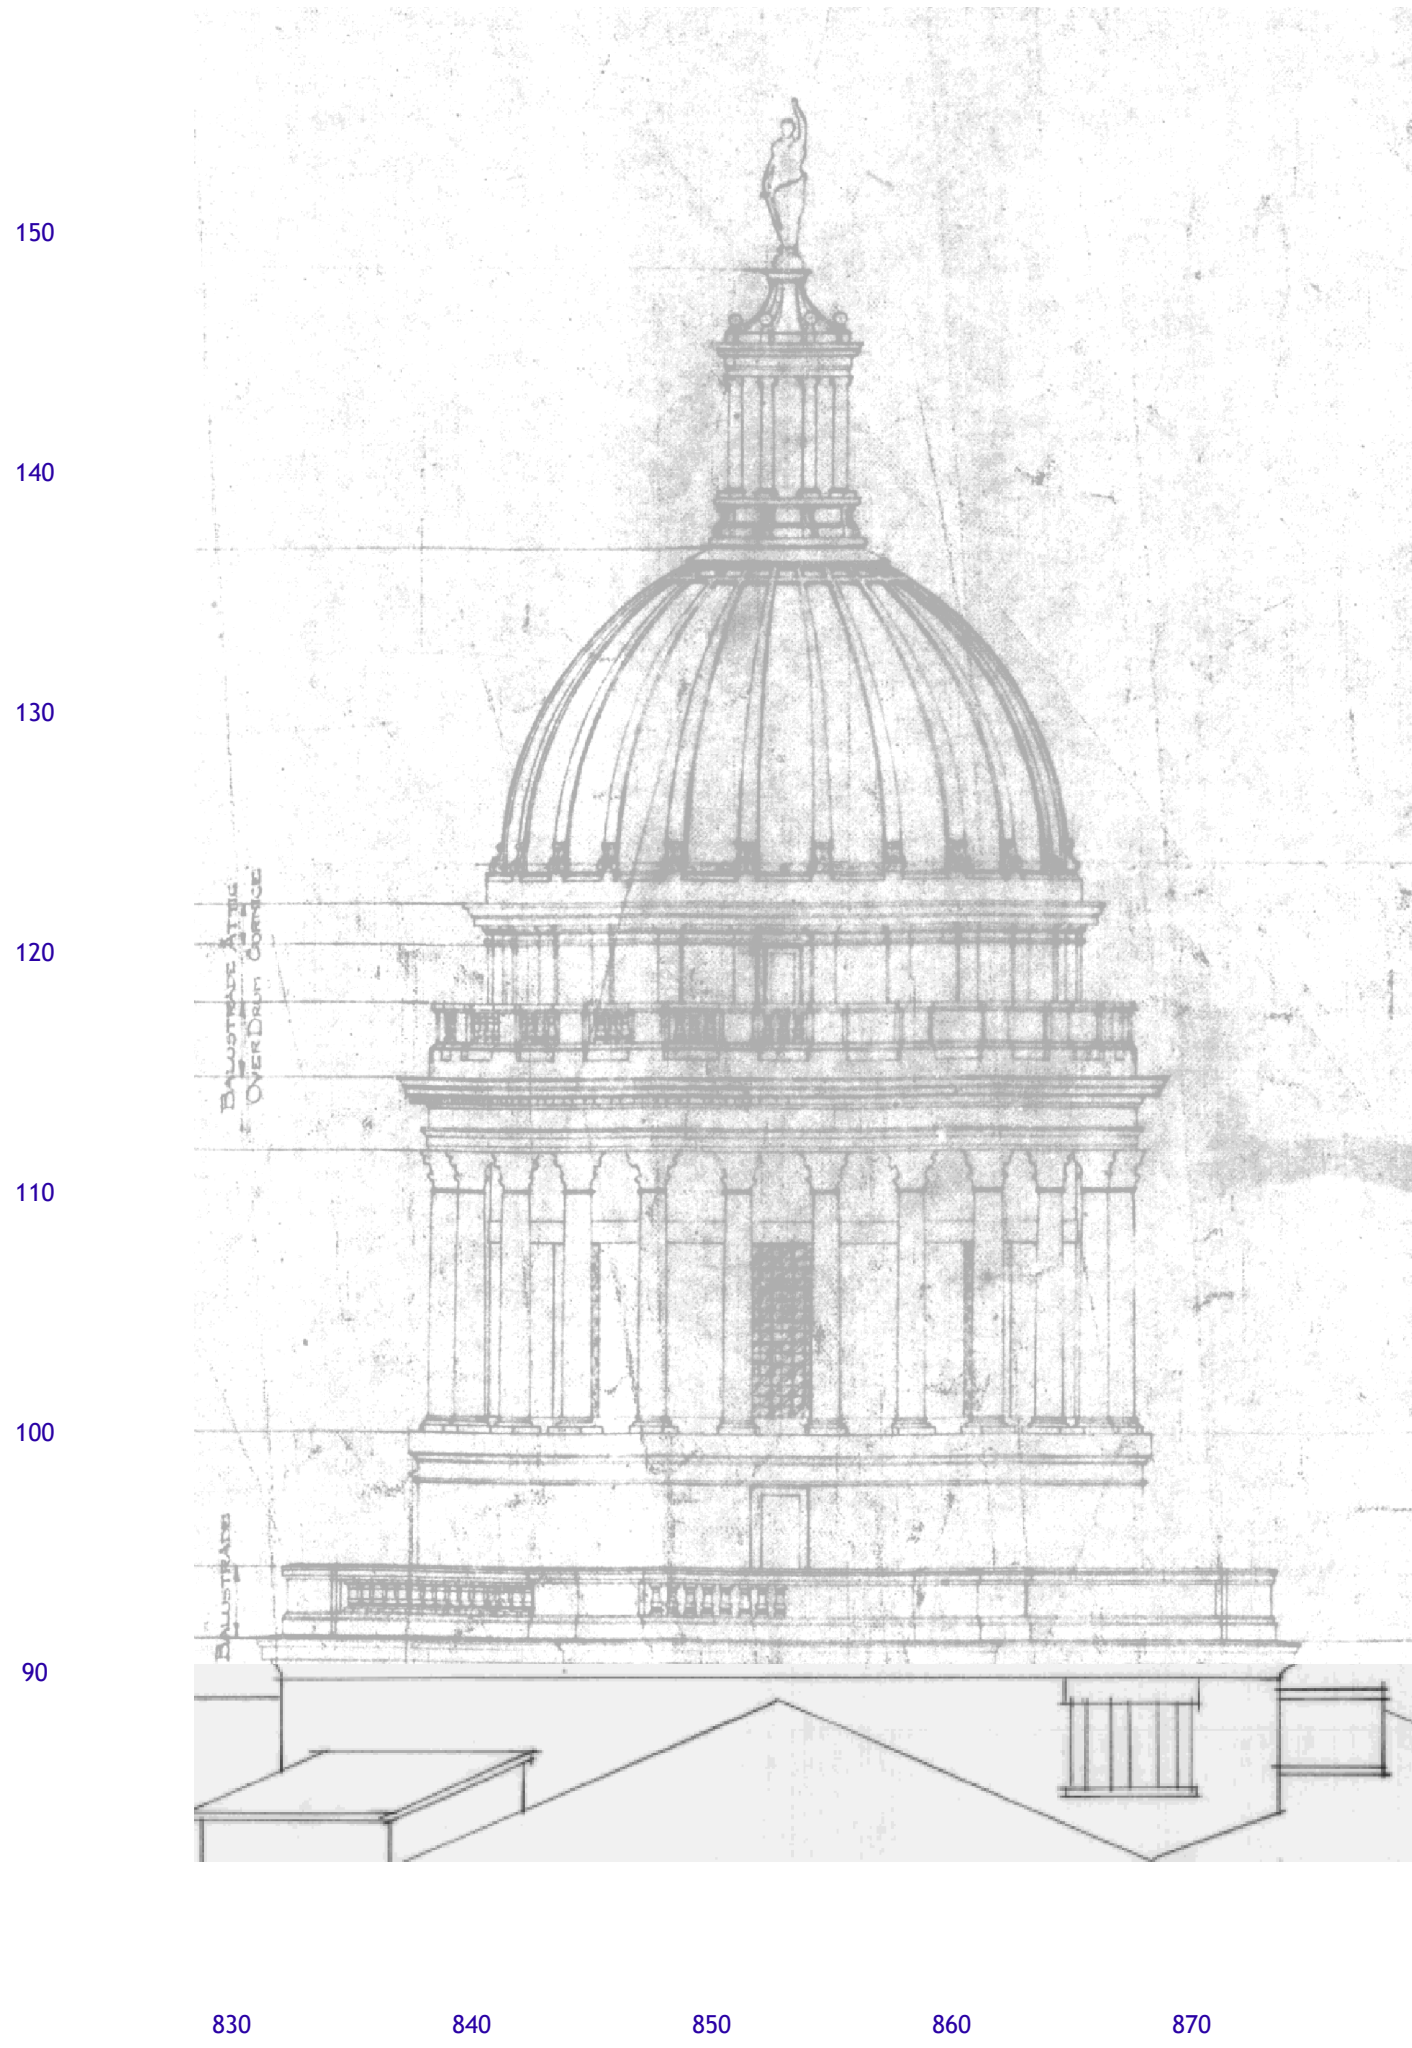
There are two drawing sheets included in the report. Sheet 1 contains the annotated elevations with the condition survey information. Sheet 2 has the locations of samples collected by Vertical Access for testing and analysis by others.

At the request of Bell & Spina, Vertical Access took paint and sealant samples to be analyzed by others for hazardous materials. Vertical Access took samples of the yellow paint and of sealant from seams at the sheet copper, joints between sheet metal and masonry, and glazing at one of the skylights on the roof of the base of the building. The locations of the samples are shown in sheet 2 of the drawings included in this report.
